# HORIZON INSPECTION SERVICES

## PROPERTY INSPECTION REPORT

**Property Address:** 1234 Anywhere; Houston, TX

**Report Number:** 060000

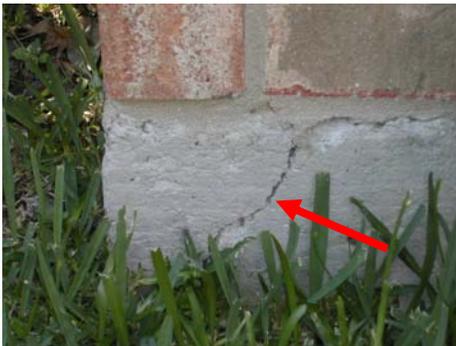
Where visible, the perimeter beam revealed no sign of distress. Foundation corner fracture(s) existed which are generally the result of differential movement between the masonry walls (expanding) and the concrete foundation (shrinking). Although this condition did not appear to adversely affect the structure, sealing these cracks may be desired as they could provide hidden access for wood destroying insects. A Structural Pest Control licensee can be retained for more specific information. Please note that the corners should be examined periodically. If the fracturing worsens and the corner(s) break off then the brick veneer may lack proper support and repair would be needed.

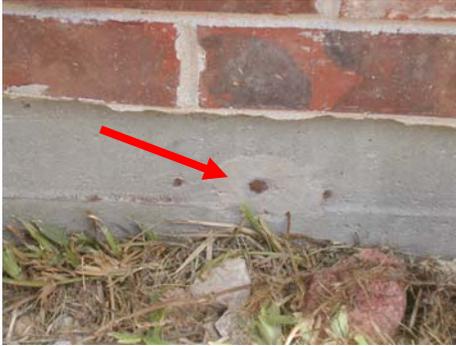
- ◆ Exposed/rusted post tension cable ends existed at the right and rear perimeter beams indicating the need for repair. Exposure to the elements can cause rusting and reduced strength. The cables should be cleaned and covered over with a non-shrink/non-metallic grout. Under no circumstances should the grout used for this repair contain any chemicals known to be destructive to the prestressing steel. Contact a *qualified* service company for corrective action. Please note that some areas of the perimeter beam(s) was/were hidden from view by soil or vegetation; therefore, other exposed/rusted cable tendons may exist.

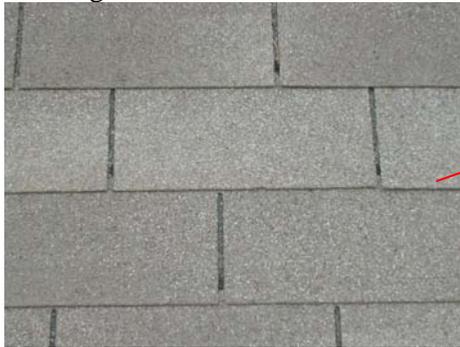
General condition of shingles

The shingles were intact and in satisfactory general condition in that no significant granule deterioration or cracking was observed.

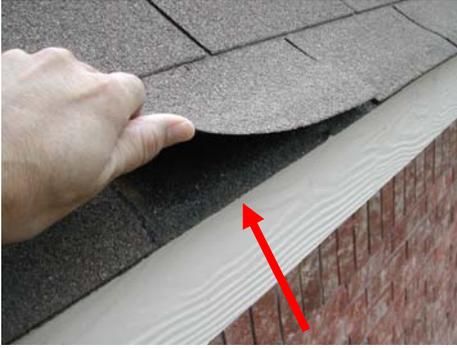
- ◆ A random check of the shingles indicates that the tabs on the starter row shingles were not bonded to the starter strip and may be vulnerable to wind uplift. Per the Asphalt Roofing Manufacturer’s Association, the bottom starter course shingle should be placed with the seal tab on the eave, facing upward, so that the first visible row of shingles has a means of sealing at the eave. This can be easily corrected by hand sealing the first course of shingles to the starter strip with an asphalt plastic cement.

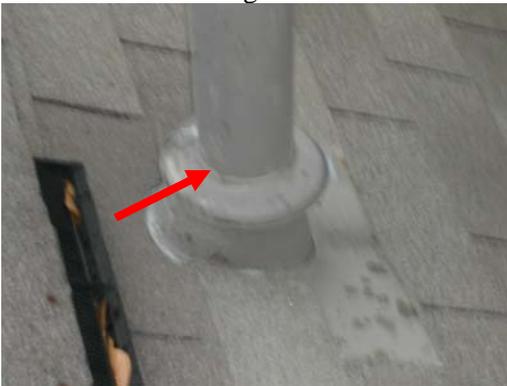
- ◆ A random check of the shingles indicates that the valley shingles were not bonded to the layer below. Per the Asphalt Roofing Manufacturers Association, each shingle end should be embedded in a 3” wide strip of asphalt cement.
- ◆ Exposed roof fasteners existed at the ridge(s) and base flashing(s). Fasteners should not be visible on the roof surface as water may penetrate around the shank(s). This can be easily corrected by sealing the exposed fasteners with a roofing mastic.
- ◆ The storm collar at the water heater exhaust pipe was not properly sealed where the pipe passes through the roof base flashing.

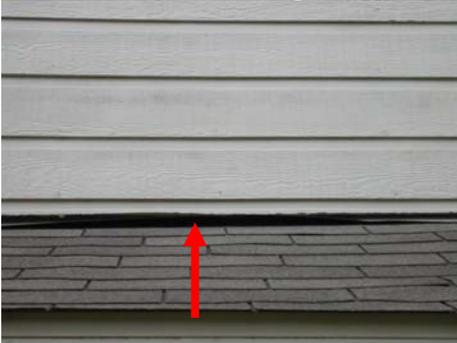
- ◆ Buckled base flashings existed at various points. All base flashings should be secured as needed.

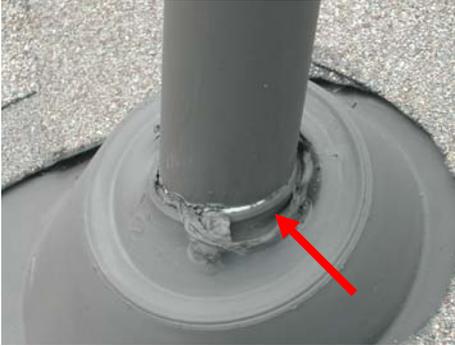
- ◆ The elastomeric material around various plumbing stacks was worn and there is a possibly of water penetration unless repaired.

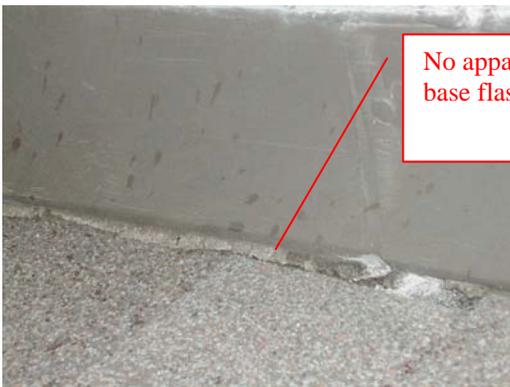
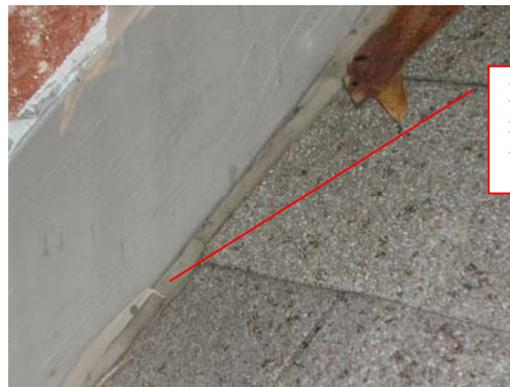
- ◆ Roof/brick veneer intersections are vulnerable to leakage due to differential movement between the materials. To help provide a water seal, a base flashing should be attached to the roof deck and brick. Counter flashing should then be installed to the brick over the base flashing. The counter flashing should be cut back into the brick veneer to create a positive seal over the base flashing. The roof/brick veneer intersections were not flashed in this manner. The base flashing appeared to extend behind the brick veneer and the installed counter flashing has no apparent function. Additionally, mastic application at various points indicates improper repair methods to correct possible leak conditions and/or defective flashing. A roofing contractor should be retained for further evaluation and remedial action.

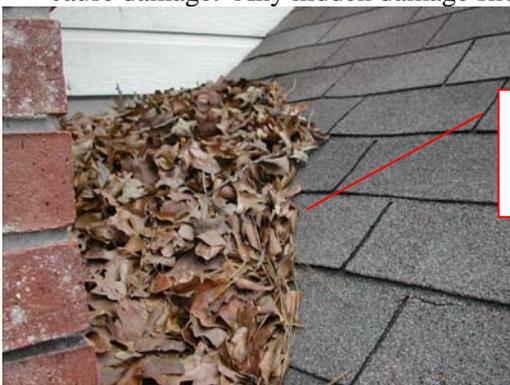
- ◆ Any debris (i.e. leaves, needles, etc.) on the roof should be removed. This debris will hold moisture and can cause damage. Any hidden damage should be repaired.

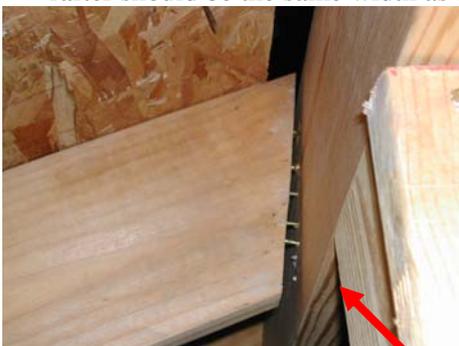
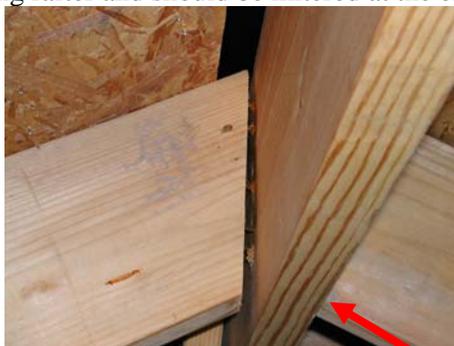
- ◆ Various rafters appeared to be poorly cut and were separated from the ridge board. This repair can be performed by nailing a supporting rafter to the existing rafter forming a tight fit at the ridge. The supporting rafter should be the same width as the existing rafter and should be mitered at the end.

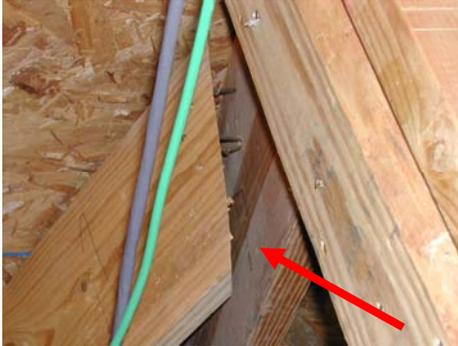
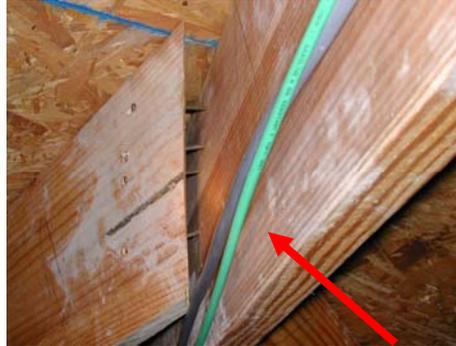
- ◆ Various hip jack(s) were poorly cut/angled and not properly fitted to the hip rafter(s). This repair can be performed by nailing a supporting member to the existing hip jack(s) forming a tight fit at the hip rafter(s). The supporting members should be the same width as the existing jack rafters and should be mitered at the end.

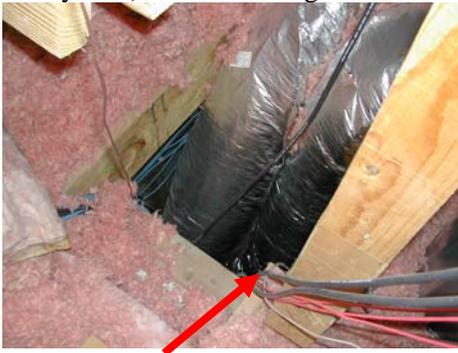
- ◆ Fire blocking was not provided at two duct chases (west side of the water heater and near the 1<sup>st</sup> story HVAC system). Fire blocking is needed to cut off these draft openings and to form a fire barrier.

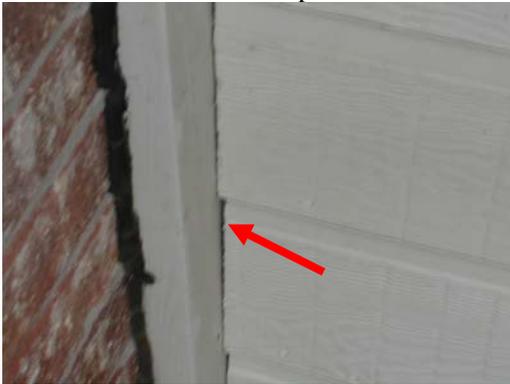
- ◆ The siding/trim boards were not caulked at various points (i.e. chimney, northeast end, etc.). These areas should be caulked to prevent moisture intrusion.

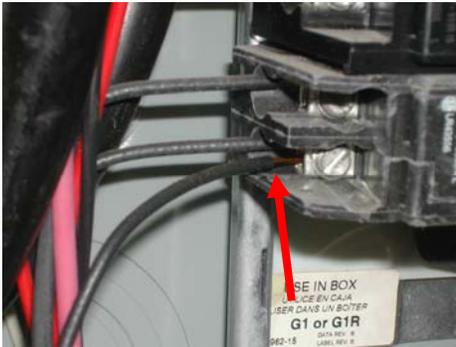
- ◆ A double wired breaker (two wires under a single lug) existed at the left side of the panel. Double tapping may not be as firm as single tapping and there may not be sufficient surface contact which can lead to circuit overloading. Since the breaker is not designed for double tapping, an electrician should be retained for remedial action.

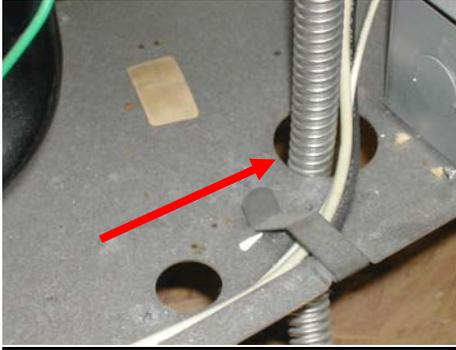
- ◆ Unit #1 & #2 - The semi rigid furnace gas tubing entered the cabinets through unprotected knockout openings. For improved safety, a hard pipe should pass through the knockout openings.

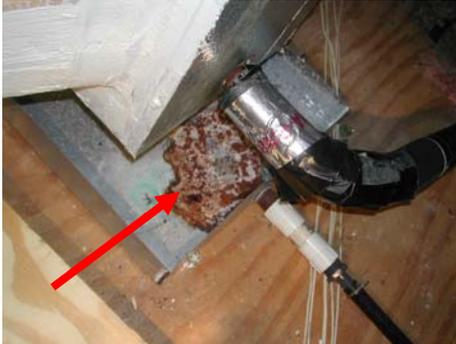
- ◆ Unit #1 - The safety pan was rusted. This suggests that the pan has held water in the past and should be closely monitored. The pan should be cleaned and examined further for hidden damage or surface wear.

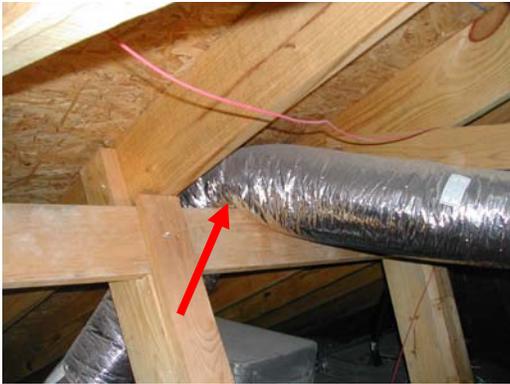
- ◆ Various ducts (in the attic) were reduced in diameter (i.e. crimps, sagging, strapping, sharp bends, etc.) which can restrict air flow. Flex ducts should be supported at intervals no greater than 4'. The maximum permissible sag is 1/2" per foot of spacing between supports. An HVAC contractor can be retained for remedial action.

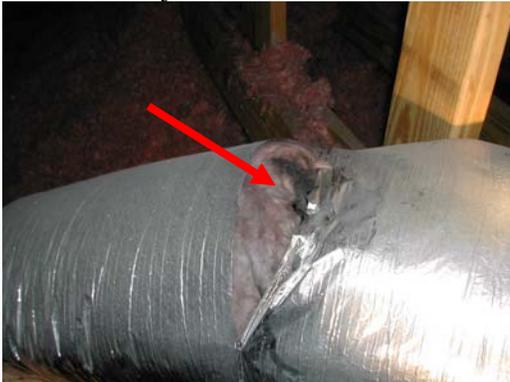
- ◆ A duct adjacent to the water heater was torn and leaking air into the attic.

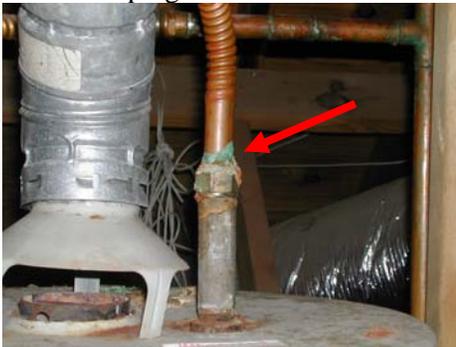
- ◆ Corrosion existed at the water heater hot water line which is an early indication of problems (i.e. leakage) developing.
